North Shore Marine Terminal – Dock Damage from LCS 21 Docking operation.

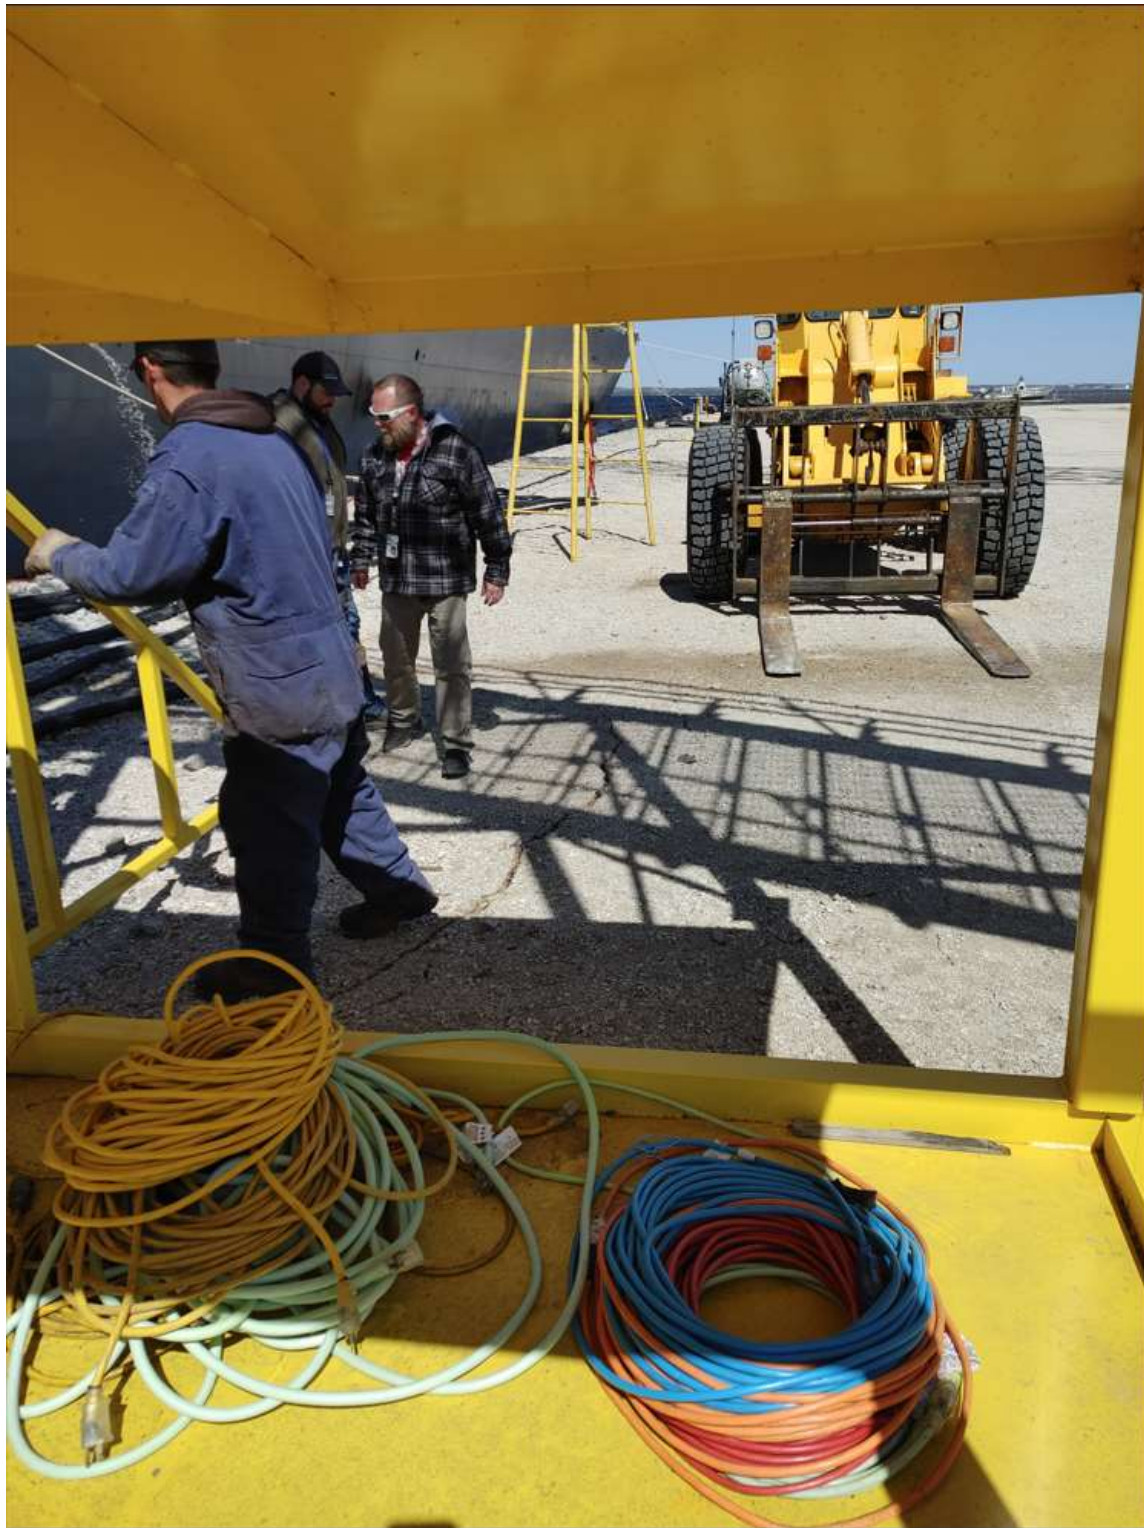
Divers confirmed that we still have substantial length of our pilings submerged into the bottom and that no material escape is occurring at time of inspection.

We have also been monitoring the existing ground and no settlement has occurred since the original incident. We continue to monitor this in conjunction with our existing operations and the area appears stable for now.

We still need to bring the dock back to original condition; however, the dock can currently be used. The only limitation would be that we should not use the jets during docking operations and should run under diesel (Prop) only with tug support as necessary.
